# **WATER OPERATION AND MAINTENANCE**

**BULLETIN NO. 158**

December 1991

## RESEARCH AND DEVELOPMENT FOR BETTER TRASH SCREENING AND CLEANING DEVICES

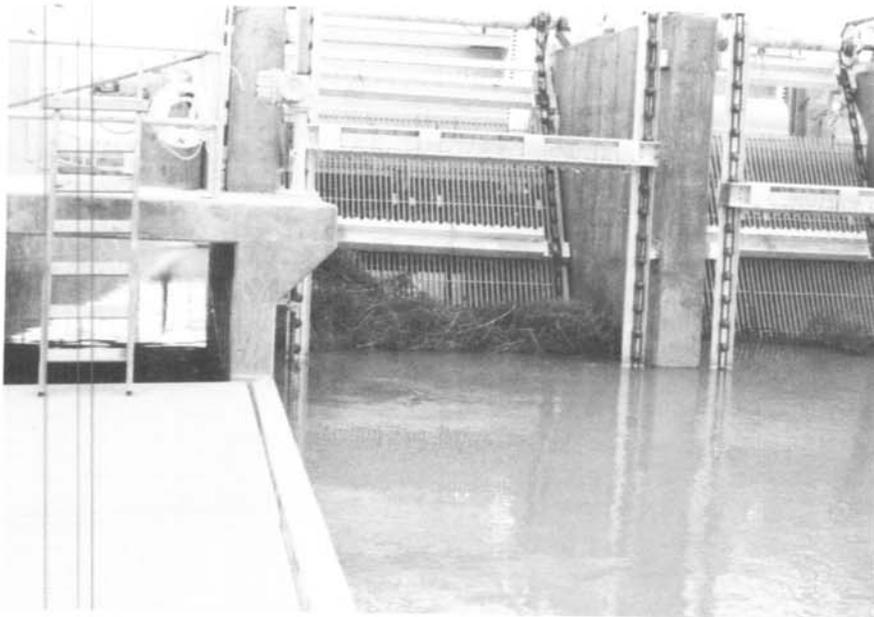
Figure 1. - A typical catenary-type trash rake located on the Government Highline Canal near Grand Junction, Colorado.

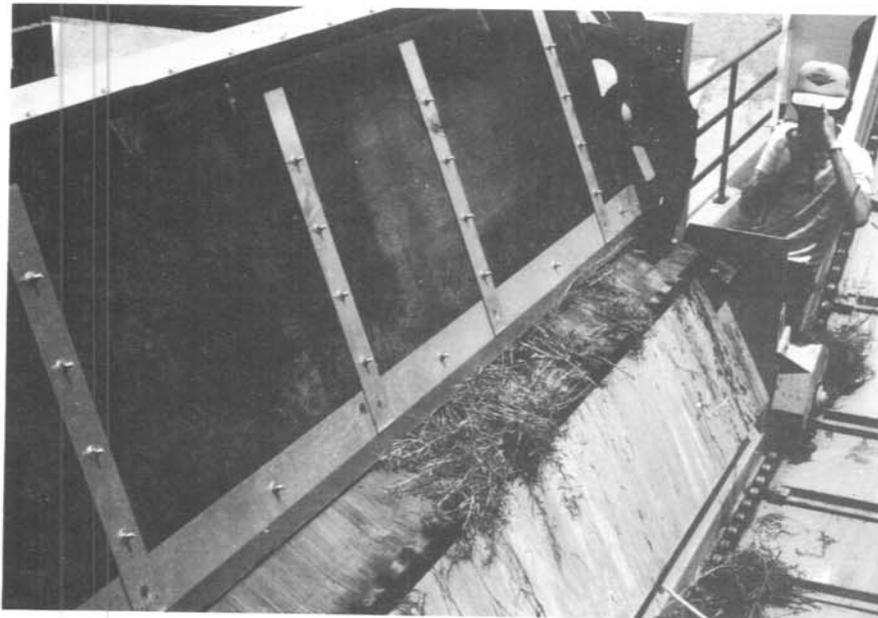
Figure 2. - Photograph showing the wiper installed by field personnel on the catenary rakes at Brady Pumping Plant. The wiper is constructed from rubber conveyor belt.

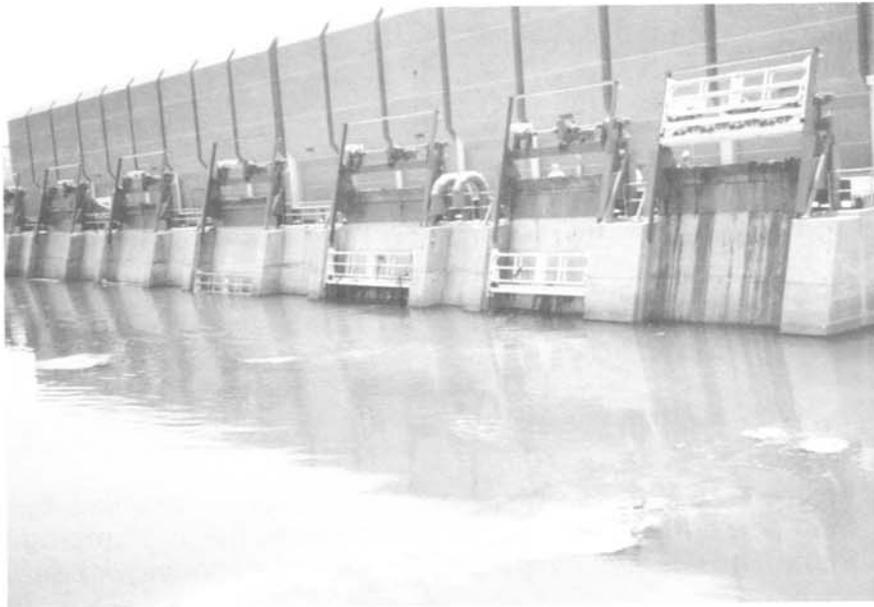
Figure 3. – Hoist-and-carriage-type trash rakes at Bouse Hills Pumping Plant on the Central Arizona Project.

Hoist-and-carriage-type trash rakes (figure 3) have a large rake head which travels on rails mounted along the edge of the trashrack. The rake head folds away from the rack face during the downward travel sequence of the rake operation. At the bottom of the rack, the head contacts a trip mechanism that swings the head into position. Teeth extend into the spaces between the rack bars. At the top of the rack, the rake head dumps the collected debris into a trough or other collection system. Since the rake head rides on rails and never touches the rack, the clearance between the rake head and the rack face must be kept to a minimum to obtain effective cleaning. This requires tight tolerances in the manufacture and installation of the rake and trashracks. The hoist-and-carriage-type rakes at Bouse Hills Pumping Plant on the CAP exemplify the problems when there are excessive clearances. At this plant the rake must carry collected debris over a concrete headwall above the trashrack, before dumping into the collection trough on the intake deck. A 1- to 2-inch clearance between the rake teeth and the headwall allows debris to fall out of the rake head and back into the water. Stringy weeds cause the greatest difficulty because they often hang out of the rake head, and their weight then pulls them back into the water.

Sediment deposition at the bottom of the trashrack also can interfere with the operation of the hoist-and-carriage-type rakes. At Hassayampa Pumping Plant on the CAP, sediment has built up on several occasions around the base of the trashracks to the point that the rake head cannot reach the bottom of the rack. This prevents the rake head from engaging the trip mechanism and swinging into the raking position.

In addition to these problems, the CAP has had many mechanical problems with the hoist-and-carriage-type rakes. These include bird-caging of hoist cables, problems with motor alignment, and missing or failed limit switches. The CAP has modified many of the hoist-and-carriage-type rakes to solve these problems.

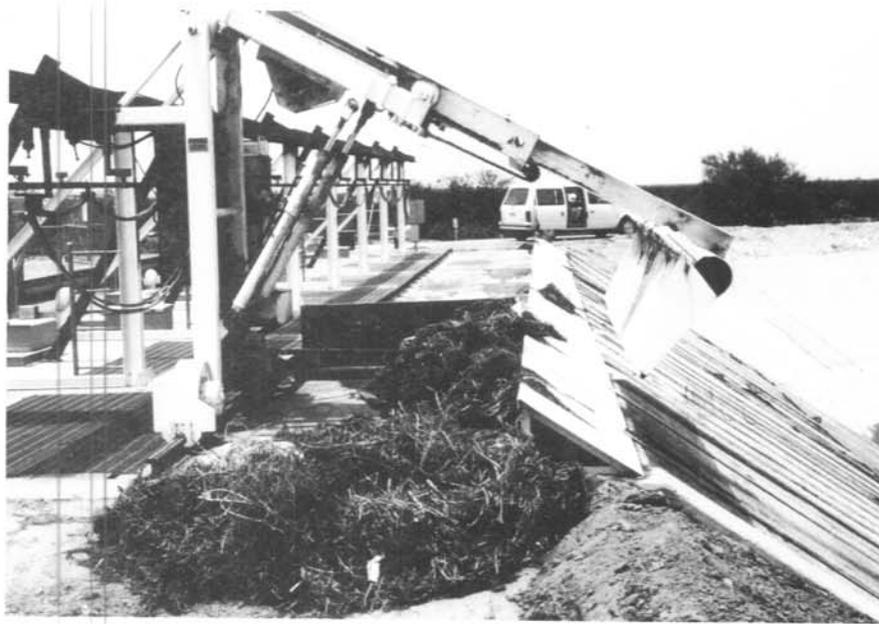
Figure 4. – Indexing hydraulic-type trash rake installed at the Santa Rosa Turnout on the Central Arizona Project.

The hydraulic-type trash rake (figure 4) is a new design that mimics the physical motions used in manual raking operations. It consists of a telescoping rake head that lifts clear of the rack face during the downward travel of the rake head. Once fully extended, the rake head swings down into position to bear on the rack face. The rake head then retracts along the rack face with the hydraulic system maintaining contact between the rake head and the rack face. Trash is dragged to the top of the rack. At the top of the rack, the rake head continues to retract, pulling weeds completely off the rack face. For use on large rack areas, indexing rake heads can be used so that one rake head serves multiple rack sections. This reduces the cost per unit area in comparison with catenary- or hoist-and-carriage-type trash rakes.

On the CAP, an indexing hydraulic-type rake has been installed on the Santa Rosa Turnout, which was originally designed to be manually raked. A non-indexing hydraulic rake also has been installed at the Harquahala Valley Irrigation District Turnout. These trash rakes have worked successfully with both stringy weeds and mosses, and bulky weeds such as tumbleweeds. These rakes have had lower maintenance requirements than other designs because of the low number of moving parts, and maintenance is simplified because the entire rake is above the water surface when not in use. Also, there is no mechanical equipment at the bottom of the trashrack, so sediment deposition around the base of the trashrack is less likely to cause problems with the operation of the trash rake. Hydraulic-type trash rakes are now the only type of trash rake being specified for new construction on Reclamation projects.

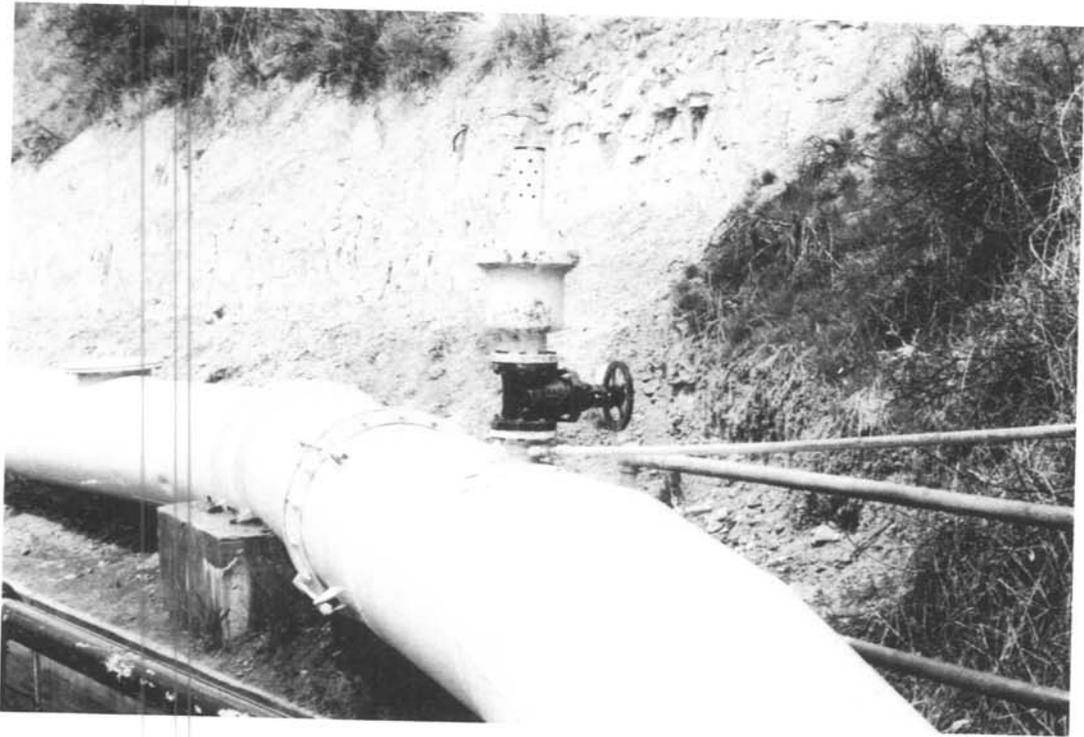
Photo 1. - Hyrum Dam, Utah—Air vent valve at upstream end of pipe.  
4/18/91

The consultant filled the penstock to check for any leakage in the pipe. After charging (filling) the pipe, he closed the regulating gates at the dam, closed the guard isolation valve (gate valve) located below the air vacuum/air release valve, and closed the pump turbine gates. He assumed that the penstock would remain full of water. But the pump turbine gates leaked sufficiently to create a vacuum in the pipe. The vacuum was enough to lead to the collapse of a 40-foot section of pipe.

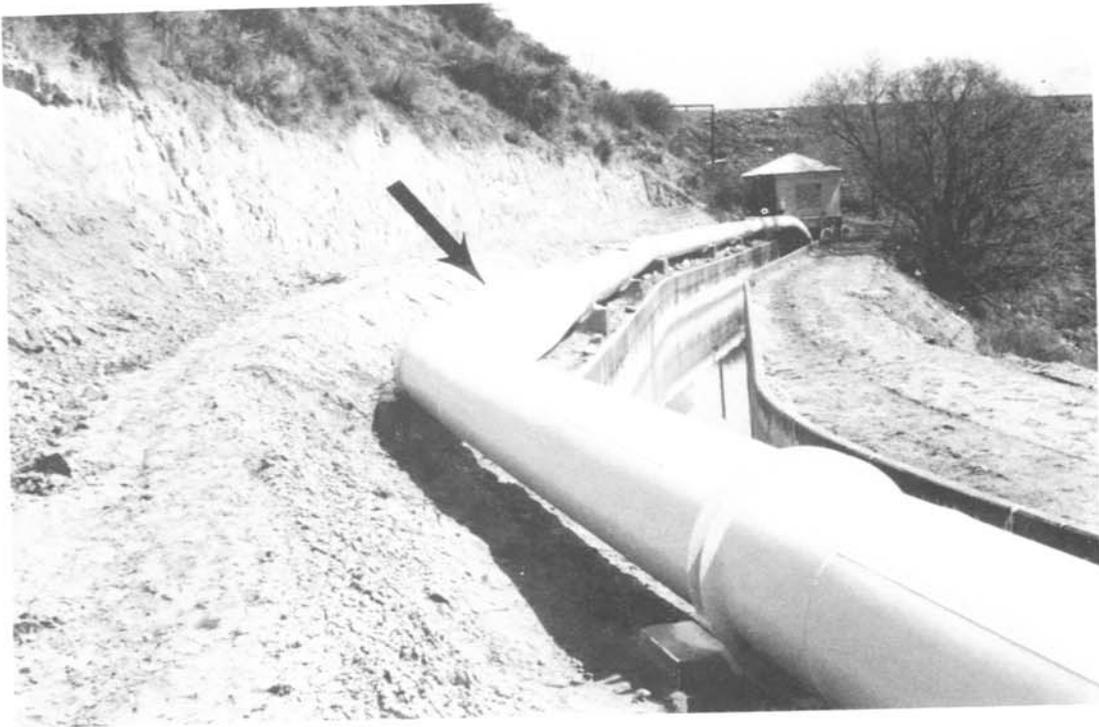
Photo 3. - Hyrum Dam, Utah—Collapsed segment of pipe (arrow) viewed from downstream. Air valve is in background near control house for outlet works. 4/18/91

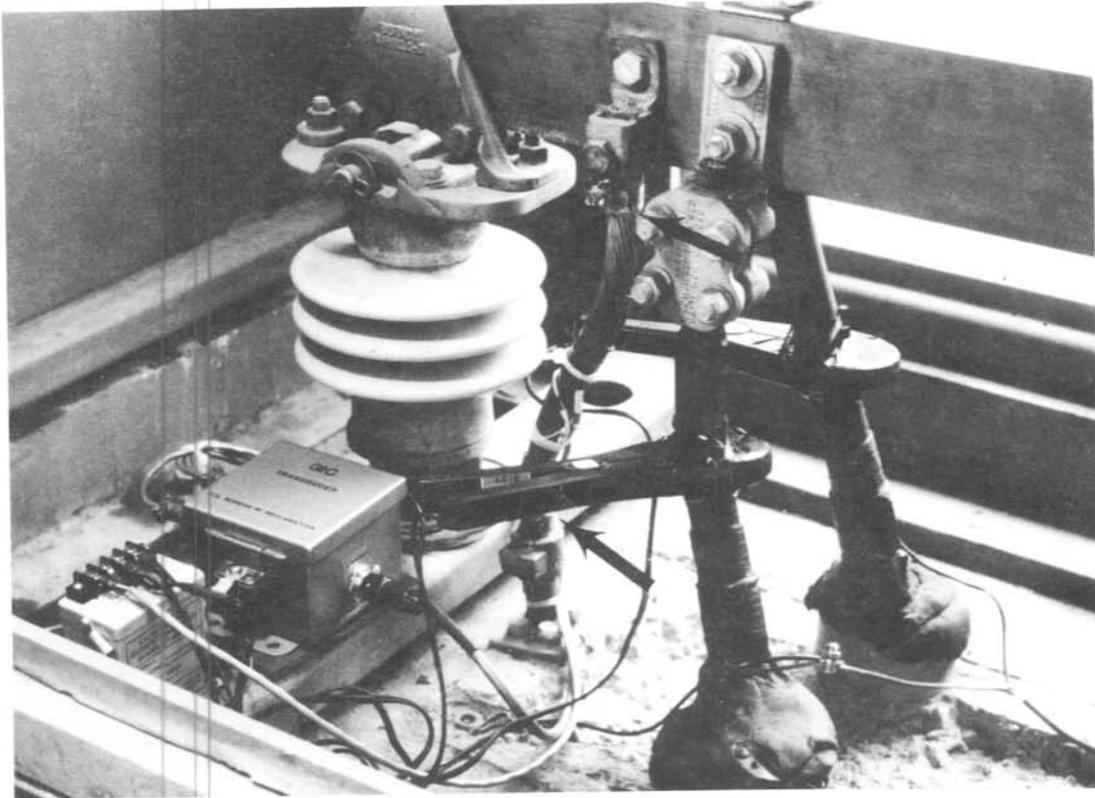
Figure 3. – Installation of the GIC transducer at Grand Coulee Powerplant.

The GIC is measured by tapping the existing transformer neutral lead as shown in figure 3 during an actual installation. The small voltage drop in the conductor is fed into an alternating-current filter-amplifier circuit to produce a measure of the direct-current component. Clamp-on current transformers (CT) are used to measure the transformer neutral phase current. A current transducer monitors the load current. Information about the second harmonic phase current component is obtained with a specially designed harmonic current transducer. The winding temperature is monitored using an available resistance temperature detector (RTD) well. The ambient temperature transducer consists of a small probe that can be installed in any chosen location.
